WL-TR-94-2092

RECIRCULATING CAVITY CASING
TREATMENT FAILURE

FINAL REPORT FOR 04/01/93 - 02/01/94

AERO PROPULSION AND POWER DIRECTORATE
WRIGHT LABORATORY
AIR FORCE MATERIEL COMMAND
WRIGHT PATTERSON AFB OH 45433-7650

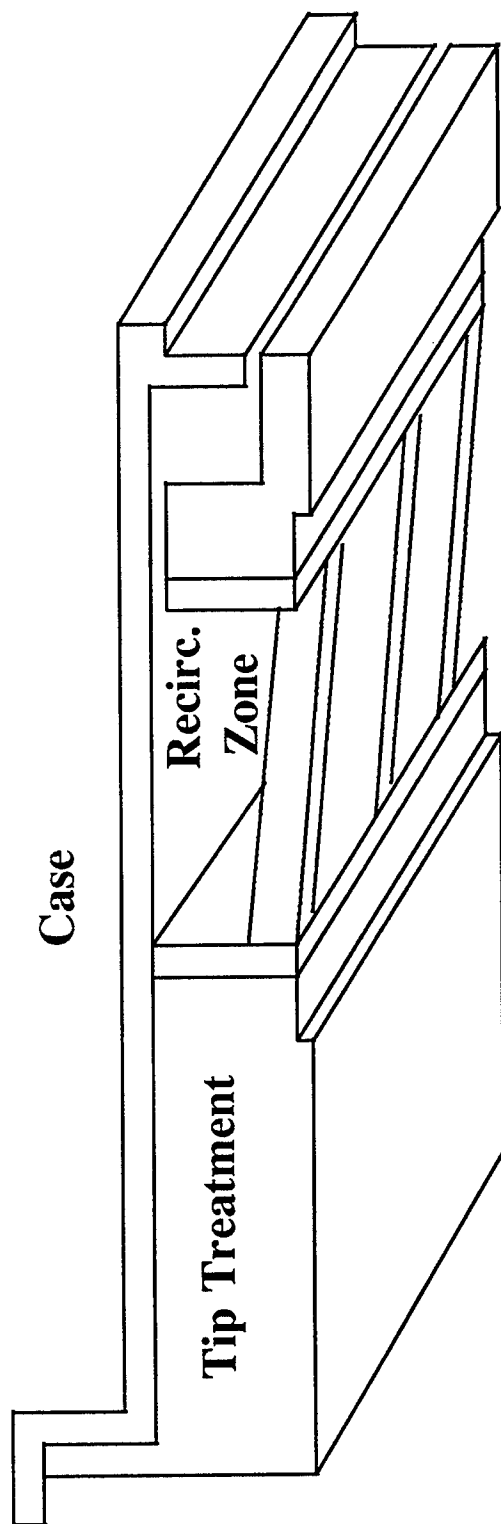
Figure 3 Schematic of Recirculating Cavity Casing Treatment

Angled slots above the first stage rotor tip join the flow path to a circumferentially continuous cavity radially beyond the slots. This is shown schematically in Figure 3. This new concept in casing treatments is made out of 6061-T6 aluminum alloy and provides 0.22-inch "fingers" above the rotor angled 15° to the axial direction. These fingers are also angled 50° to the radial direction and provides a recirculation cavity above the rotor of about 3.5 inches.
